GREAT KILLS HARBOR BREAKWATER STUDY: APPROACHES FOR A SHORELINE PROTECTION SYSTEM

TASK 2 SUMMARY REPORT

PROJECT NO. 214038.0
DOCUMENT NO. T2_02
VERSION 2.0
DATE OF ISSUE December 19, 2014
PREPARED BRCO
CHECKED TPMA
APPROVED AZSL

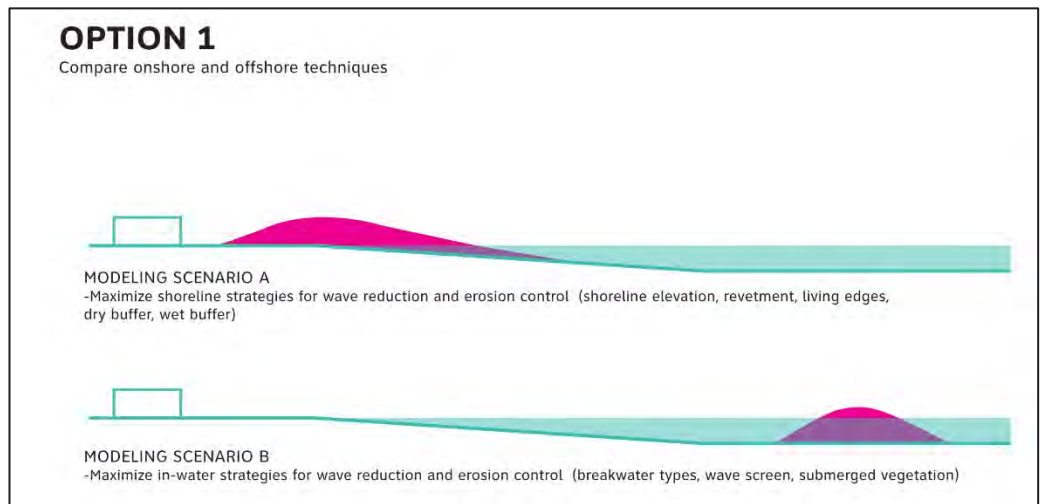
Figure 3-1: Option 1 Sections

Option 1 Scenario A: Maximize shoreline strategies for wave reduction and erosion control (shoreline elevation, revetment, living edges, dry buffer, wet buffer)

Option 1 Scenario B: Maximize in-water strategies for wave reduction and erosion control (breakwater types, wave screen, submerged vegetation)

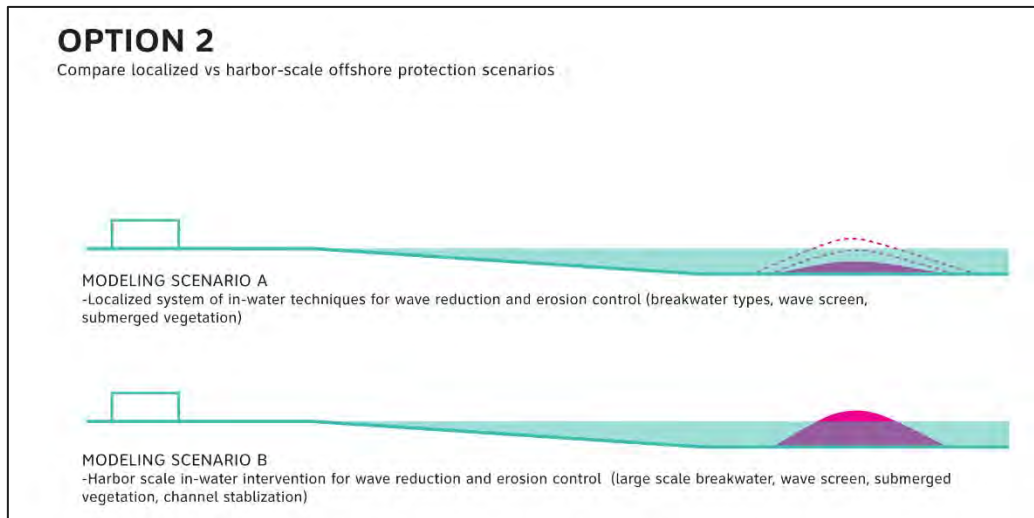
Figure 3-3: Option 2 Sections

Option 2 Scenario A: Localized system of in-water techniques for wave reduction and erosion control (breakwater types, wave screen, submerged vegetation)

Option 2 Scenario B: Harbor-scale in-water intervention for wave reduction and erosion control (large scale breakwater, wave screen, submerged vegetation, channel stabilization)

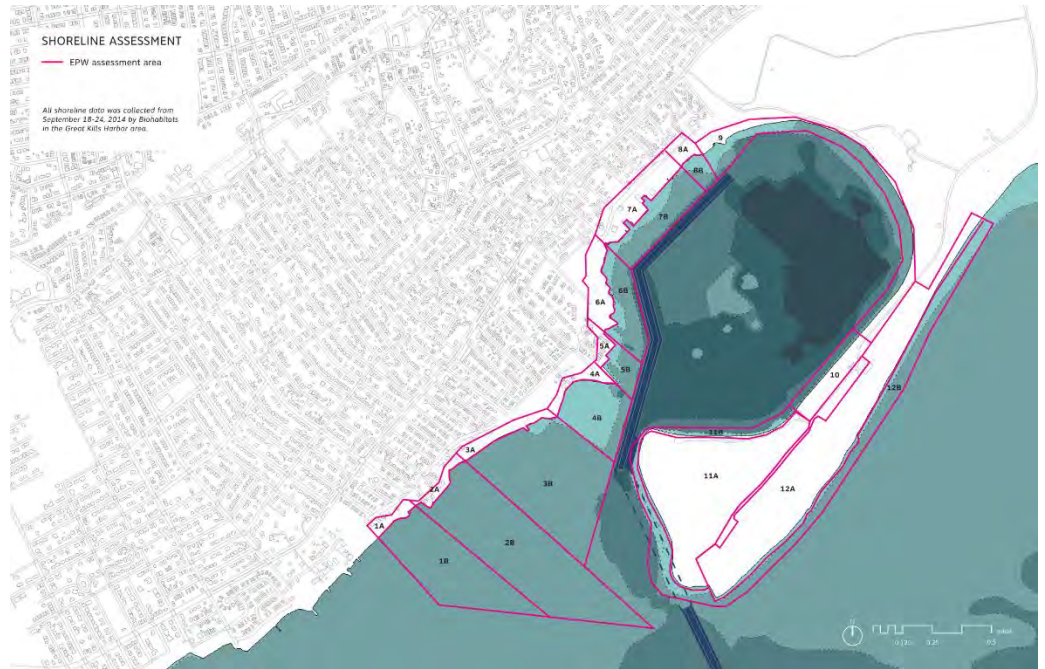
Figure 5-1: Upland and Littoral Zone Investigation Sections

To conduct the EPW analysis, the site was divided into 12 distinct areas as shown in Figure 5-1. The areas were broadly defined by the shoreline characteristics observed on site during field visits which occurred in September 2014. Existing conditions for each site are described below and photos of each section are located in Appendix C.

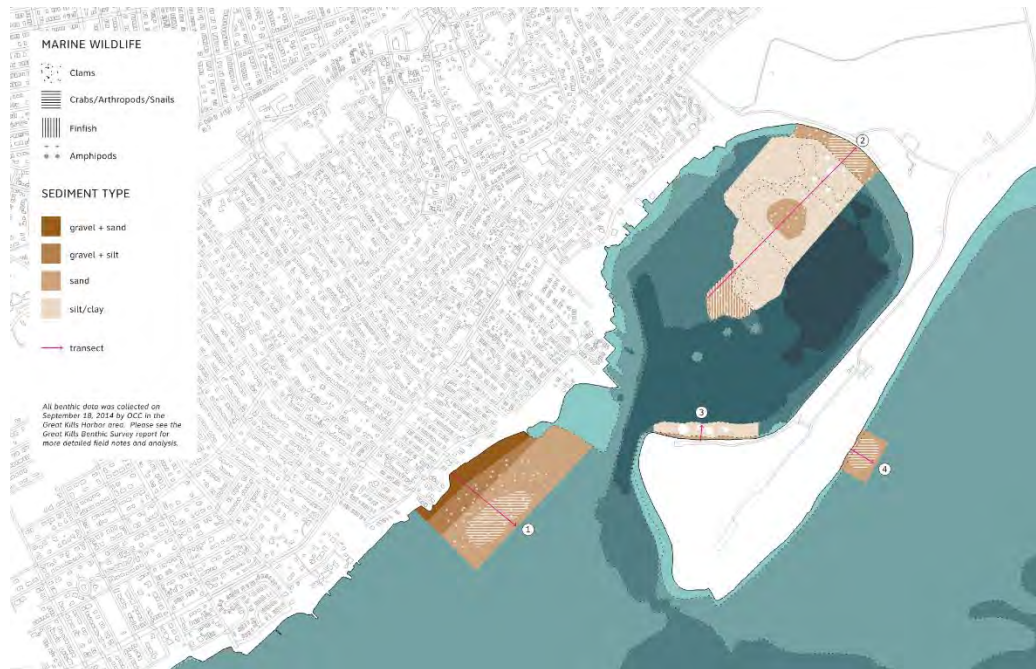
Figure 5-2: Underwater Investigation Diver Transects

On September 18, 2014, OCC divers and a marine biologist, accompanied by representatives of Biohabitats and SCAPE, completed a benthic survey of Great Kills Harbor inter and subtidal habitats. A detailed summary memo, including photographs, was prepared by OCC|COWI and has been included in Appendix C; select highlights from the underwater investigation are presented here. The study consisted of four shore perpendicular transects, detailed in Table 5-3, below.

Positioning was accomplished using the vessel mounted Differential Global Positioning System (DGPS). This positioning procedure facilitated locating the transect lines, video recording, sediment sampling and local conditions reporting.
