NEW YORK STATE WATER RESOURCES INSTITUTE

Assessing the Effectiveness of Green Infrastructure

Emily Vail, Department of Natural Resources, eev22@cornell.edu

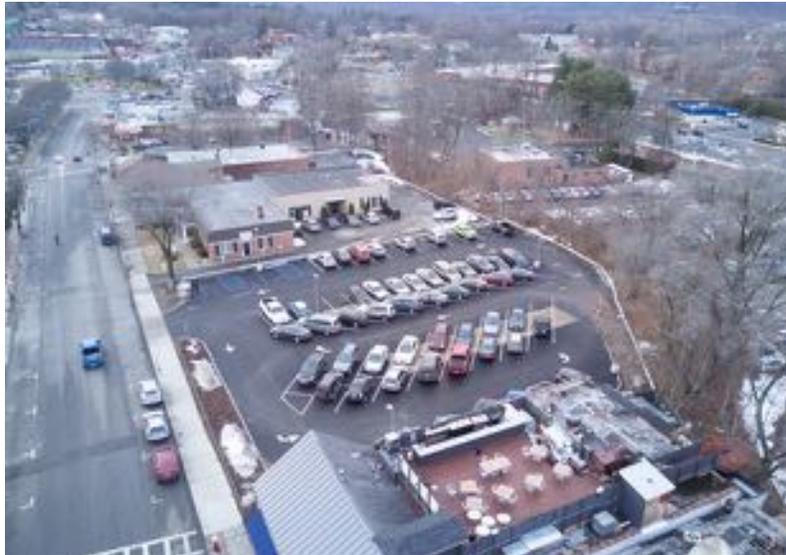
Aerial photo of Kingston's Uptown Parking lot and green infrastructure practices (Shawn Willis, Notice Pictures)

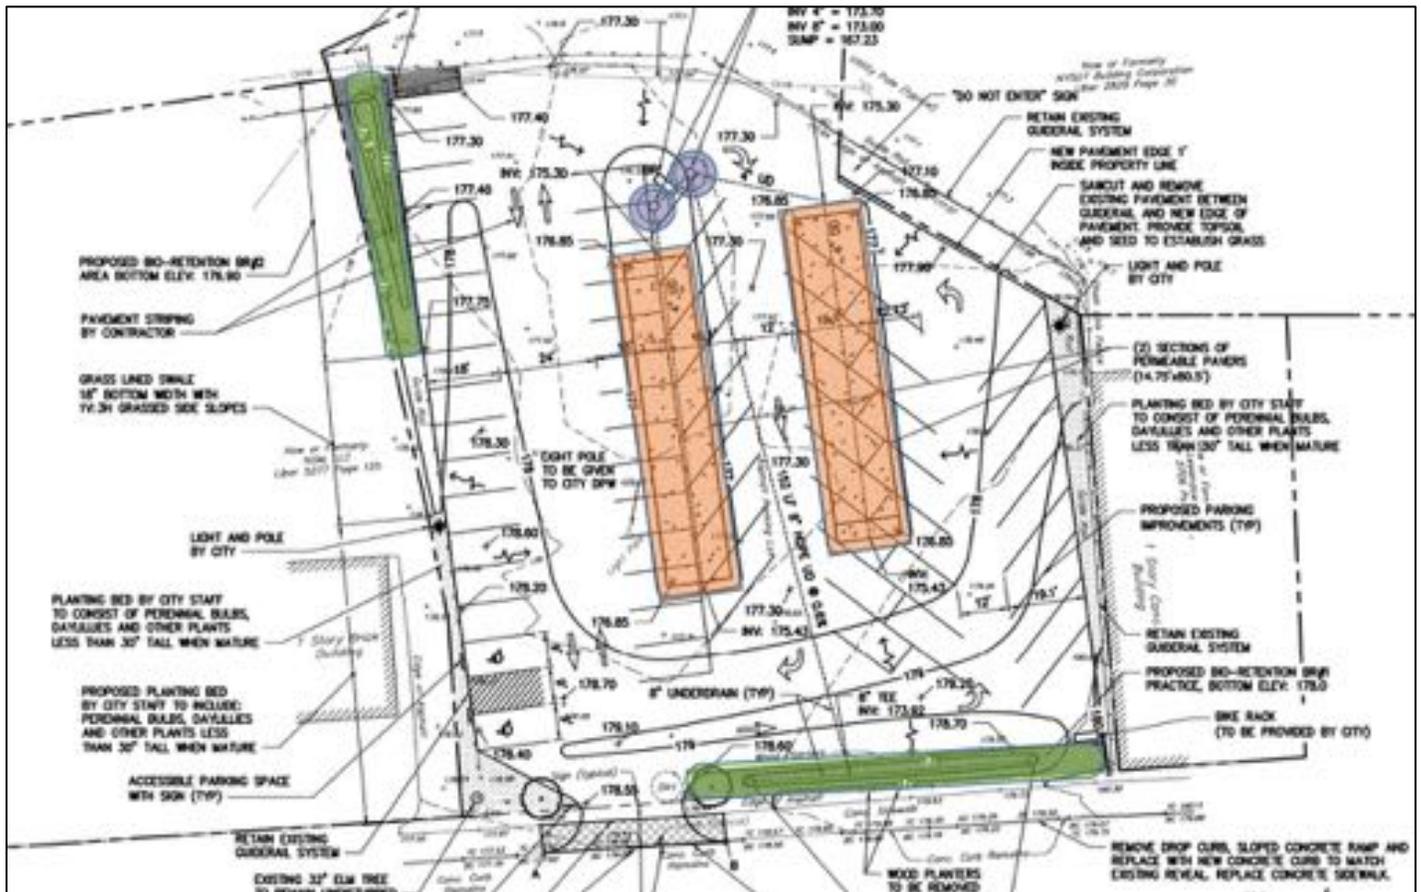
Figure 2: Engineering plans for the North lot, with bioretention areas (green), pervious pavers (orange), and dry wells (purple) highlighted (Barton & Loguidice 2015).

The North lot has two bioretention areas (one with underdrain, one without), two dry wells, and two sections of pervious pavers.

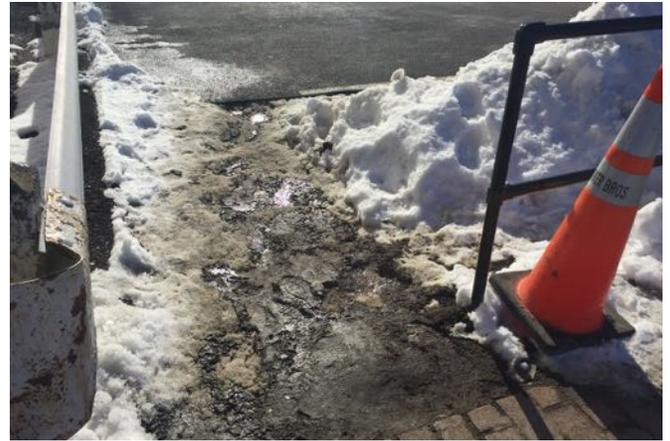
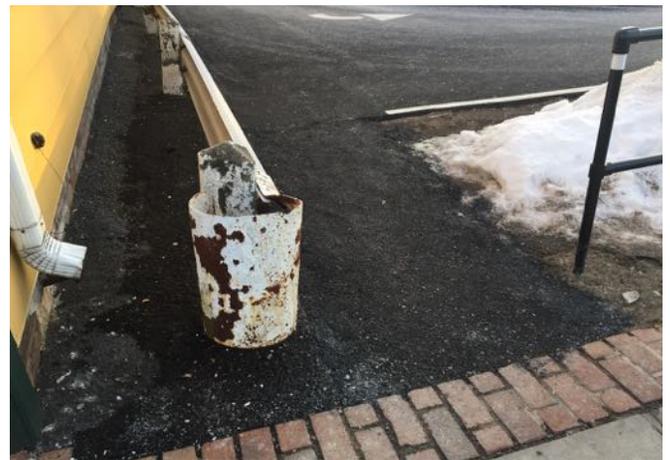
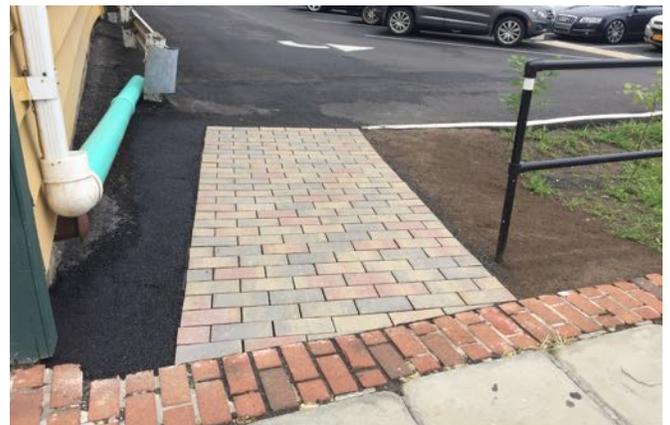
Figure 4: Series of photos showing the progression of an informal walkway to a formal walkway through Bioretention Area South 1. From top to bottom, photos were taken on 1/1/17, 1/6/17 when gravel was installed, and 7/14/17 when block pavers were installed. This area was originally part of the stormwater practice, and the walkway reduces its designed storage capacity (photos by E. Vail).

The City of Kingston has had to make several changes to improve the design of the parking lots, which have implications for the stormwater practices and their function. These have included regrading around two of the dry wells (Dry Well South 1 and 2), installing fences to prevent cars from driving through the bioretention areas, and creating walkways alongside the bioretention areas for pedestrians to cross from the parking lot to the business area (Bioretention Areas South 1 and 2, Bioretention Area North 1).

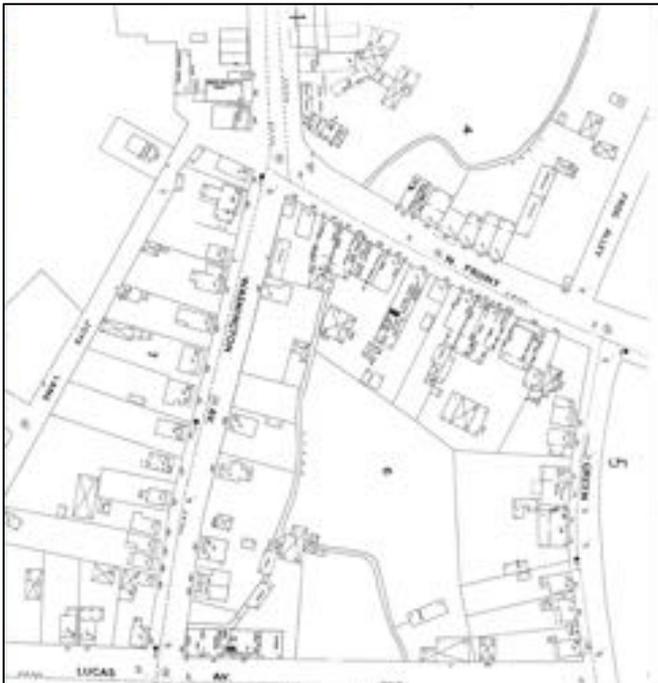
Figure 5: 1899 Sanborne map showing the Tannery Brook's path and its confluence with Main Street Brook, its largest tributary. Maps like this one reveal the stream's historic path, in addition to shedding light on the relationship of the city with the Tannery Brook.
